ROYAL COMMISSION

QUEBEC BRIDGE INQUIRY

1907

MINUTES OF PROCEEDINGS

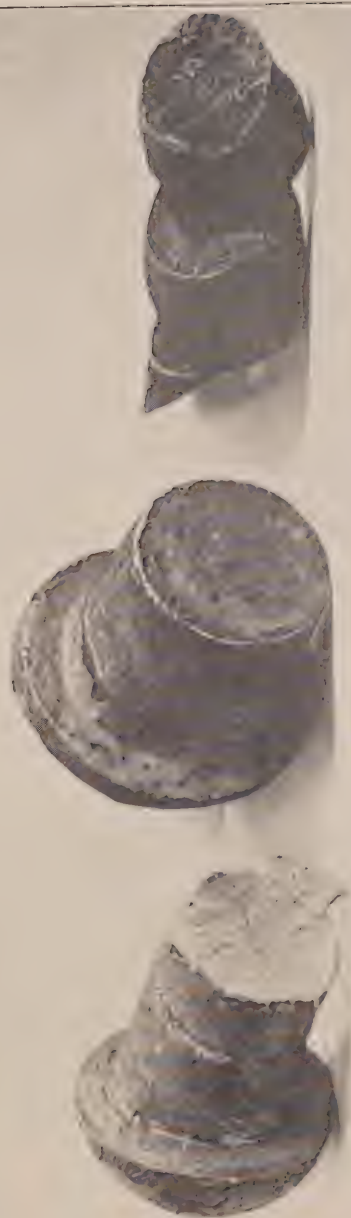
22 Shows two rivers having typical shanks in shanks; it also shows a typical river shank (disturbed second recognition of texture and shape).
